# DEBRIEFING

## SAR TECH ELECTROSTATIC DISCHARGES

(05 Dec 03 - Occurrence #114440

(17 Dec 03 - Occurrence # 114548)

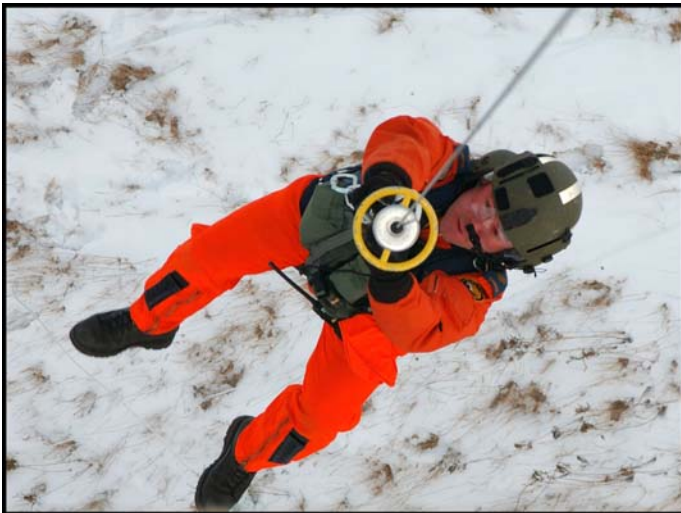
Two electrostatic discharge (ESD) incidents recently took place during live hoisting training from CH149 Cormorant helicopters.

The first incident occurred when the first SAR TECH reached approximately 15 ft AGL and the Flight Engineer (FE) noticed an unusual hand signal by the SAR TECH. The SAR TECH was hoisted in and secured; he was noticeably "stunned" and was administered first aid. There was no pulse present for a short period of time. Upon return to Base, the SAR TECH was taken to MIR for examination. The second occurrence happened 12 days later while the second of two SAR TECHs being hoisted down encountered a series of strong ESDs which prevented him from undoing the pip pin on the hook. Discharges started at approximately 3m above ground from a 20m hoist.

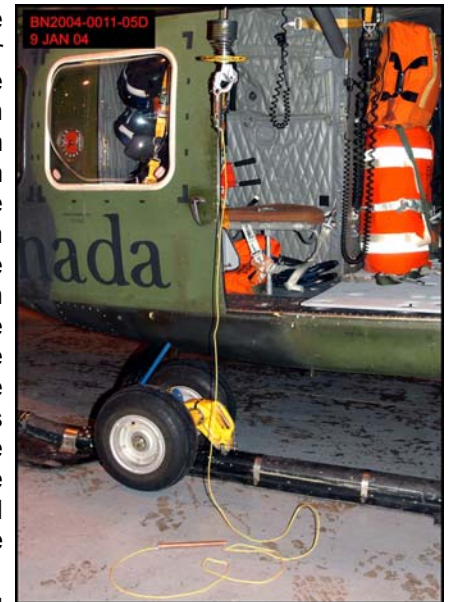
**Debriefing.** These two incidents are still under investigation and have raised concerns for the safety of our SAR TECHs. It may be useful to ponder a few points. First, reporting and documenting these events are key in ensuring that effective preventive measures can be implemented in a timely manner. We have some concerns that some ESD incidents have not been reported. The potential for injury must be the key factor in deciding whether or not ESD incidents should be reported. It is essential for all to gather as much information as possible on this; for example, the weather conditions, the temperature, the humidity, etc. may contribute to the accumulation and dissipation of electrostatic charge. The FSIS occur-

rence report is an ideal tool for reporting these incidents. The Hazard Reports can also be used to help identify and track these risks. Second, we could learn from other helicopter fleets to see if any preventive measures could be adapted to the Cormorant. A quick search on the FSIS revealed that at least nine (9) similar incidents occurred from 1983 to 1999, three (3) were on the CH124 and six (6) on the CH146. There were no incidents reported after 1999. This leads us to believe that the preventive measures introduced on these aircraft were effective in preventing or mitigating occurrences of ESD. One of these measures was the introduction of a static discharge cable (SDC) or grounding cable used by SAR TECHs for hoisting whenever the weather conditions were favourable for ESD. The cable is still undergoing certification but has proven to help reduce and even eliminate the effects of ESD. It is even designed to penetrate snow to a certain depth. The principle of the cable is that the discharge will follow the path of least resistance. The static cables are designed to be less resistant than human bodies and if the static cable is hanging below the SAR TECH's feet, the ESD should go through the cable. Also, electrostatic charges accumulate on sharp edges or points that is why the shocks are received in the wintertime through the fingers rather than large parts of the body. Another reason to suggest that the ESD will go through the cable is the pointed end of the cable compared to the boot shape. This simple fix may be the solution for the Cormorant and could be authorized in the near future.
